## NOTICE OF SPECIAL MEETING

**Staff recommends that City Council conduct a workshop to review the Citywide Public Safety and Public Facilities Master Plan Updates and provide feedback.**

The Citywide Public Facilities Master Plan (CPFMP) Update provides a comprehensive update to the 2013 CPFMP by evaluating the condition of existing public facilities and determining current and future public facility needs. The CPFMP Update includes facility condition assessments of all City facilities with recommended improvements for proposed new public facilities projects. Recommendations for renovations at City Hall, improvements and new facilities at the Boyd Service Center, and an expansion of the Community Center and Lolly Hansen Senior Center are provided as well.

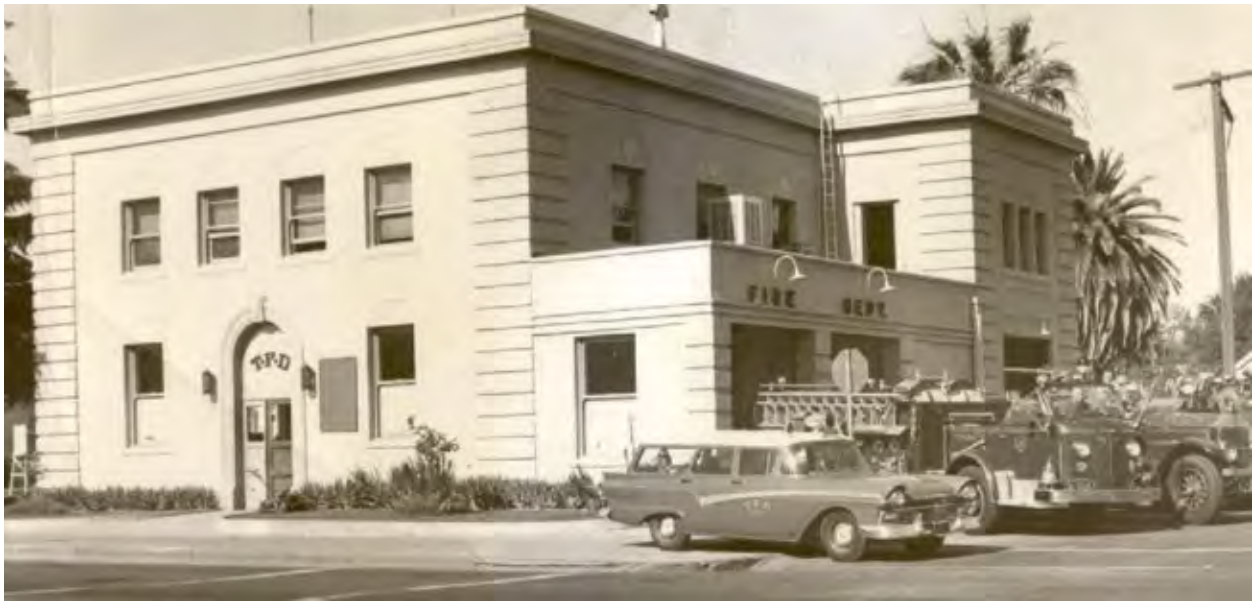
**Figure 20 – 1916 Tracy Fire Department Building, 835 Central Avenue (to be upgraded)**

In 1916, the City passed a bond that provided for renovations of the Administration Building on a 0.6 acre site at 835 Central Avenue. This building also served as the City Hall and Jail until city offices were moved out in 1947. With the recent renovations completed, this landmark building continues to serve as the Fire Department's headquarters 106 years later and remains in good condition. The use of office spaces have changed since the previous master plan, including the South San Joaquin County Fire Authority's addition of a prevention bureau, and just more overall staff in general. These offices have displaced some existing Fire Training space, which will be relocated to the new Fire Training Facility site, currently under Phase 1 construction and to be expanded to 5.13 acres with classroom and office space during future Phase 2 & 3 renovations.

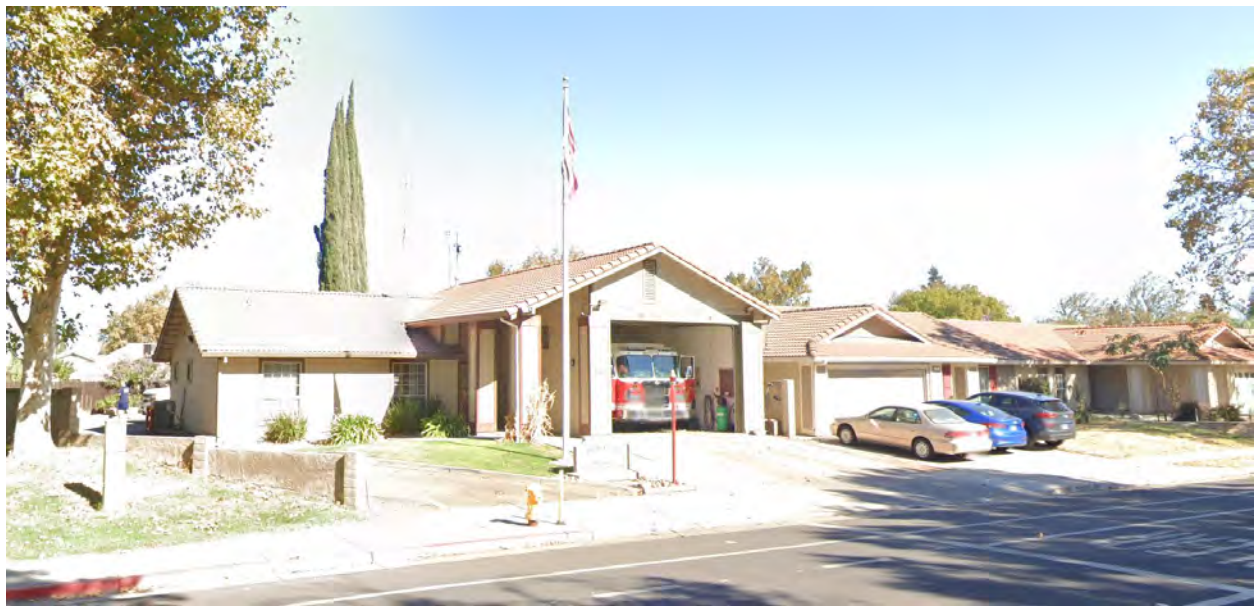
**Figure 22 – 1986 Tracy Fire Station 97, 595 West Central Ave (to be relocated w/ expanded ladder truck bay)**

In 1986, the City built the 3,000 square foot Fire Station 97 at 595 West Central Ave. The condition of this 35-year-old facility is fair, and more significantly it is 40% of the size the South San Joaquin County Fire Authority (SSJCFA) now needs. Station 97 currently houses a 2015 Spartan Hi-Tech, type 1 pumper and is also staffed with three personnel trained to the Advanced Life Support (ALS) level.

This master plan supports the relocation of Fire Station 97 to a new 7,750 square foot facility on a 2 acre site in the Valpico area. This proposed station will include an extra 700 square feet for an extended ladder truck bay. This plan proposes that the City sell that decommissioned property once the replacement station has been built.

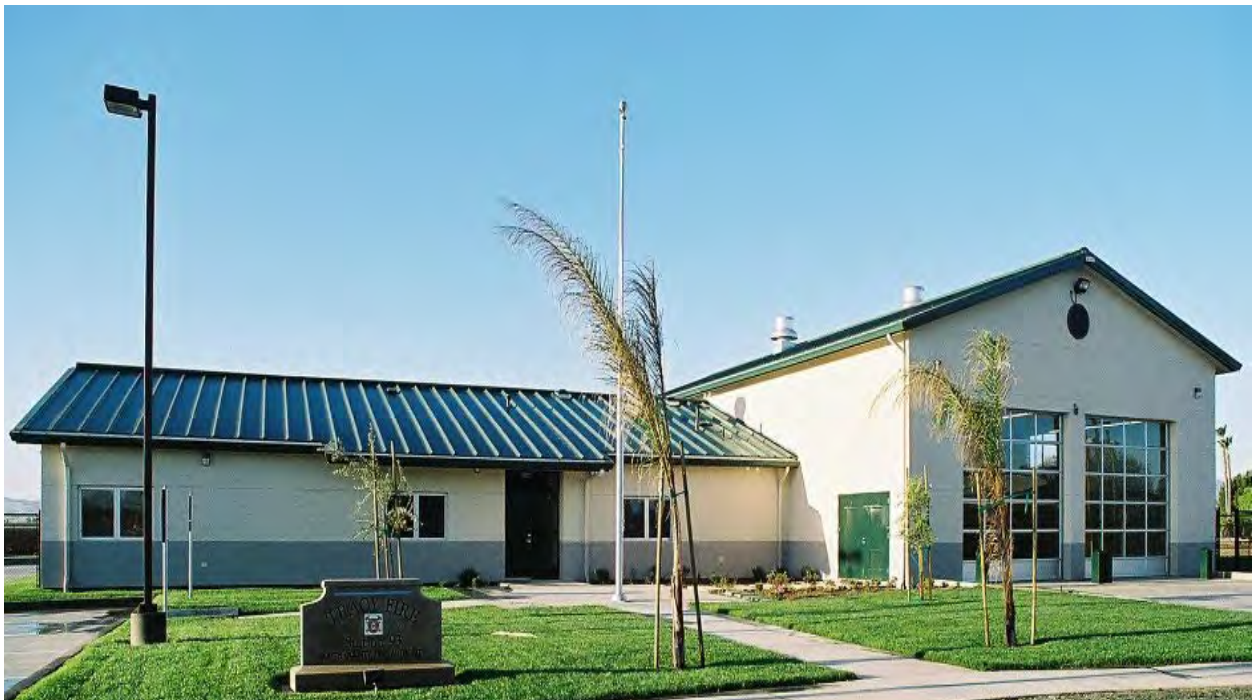
**Figure 28 – 2006 Fire Station 93, 1400 W. Durham Ferry Road (to remain)**

In 2006, Tracy Rural Fire District’s Station 93 was relocated to a new 6,200 square foot facility at 1400 W. Durham Ferry Road. Station 93 houses a 2008 Pierce Saber type 1 pumper ALS unit staffed with three personnel. This facility is in good condition.

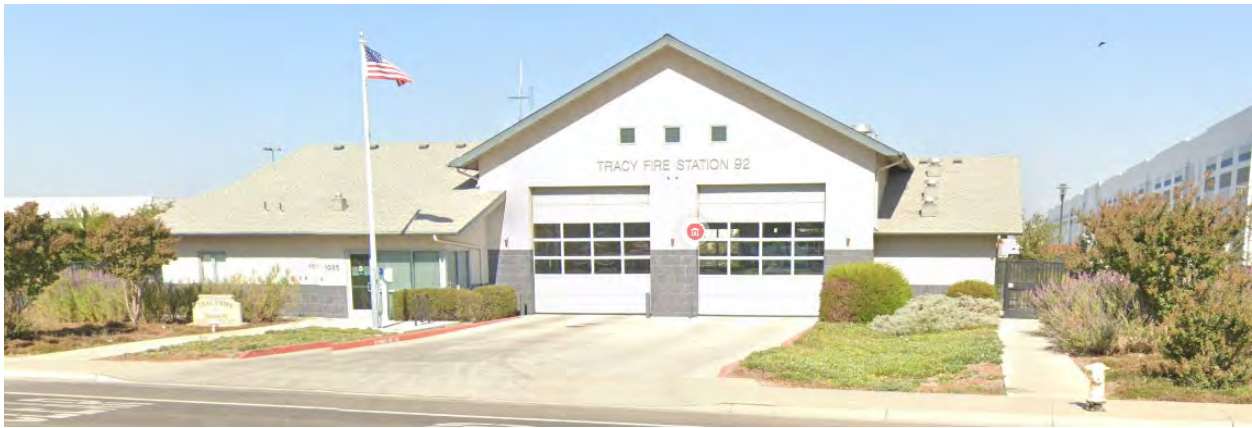
**Figure 29 – 2014 Fire Station 92, 1035 East Grant Line Road (to remain)**

Tracy’s Fire Station 92 moved into the Northeast industrial area at 1035 E. Grant Line Road. Station 92 houses a 2015 Spartan Hi-Tech, type 1 pumper ALS unit staffed with three personnel and a 2008 HME, type 1 pumper from the California Office of Emergency Services (CalOES). Station 92 shall receive radio system upgrades – see [Figure 20](#) for more information.

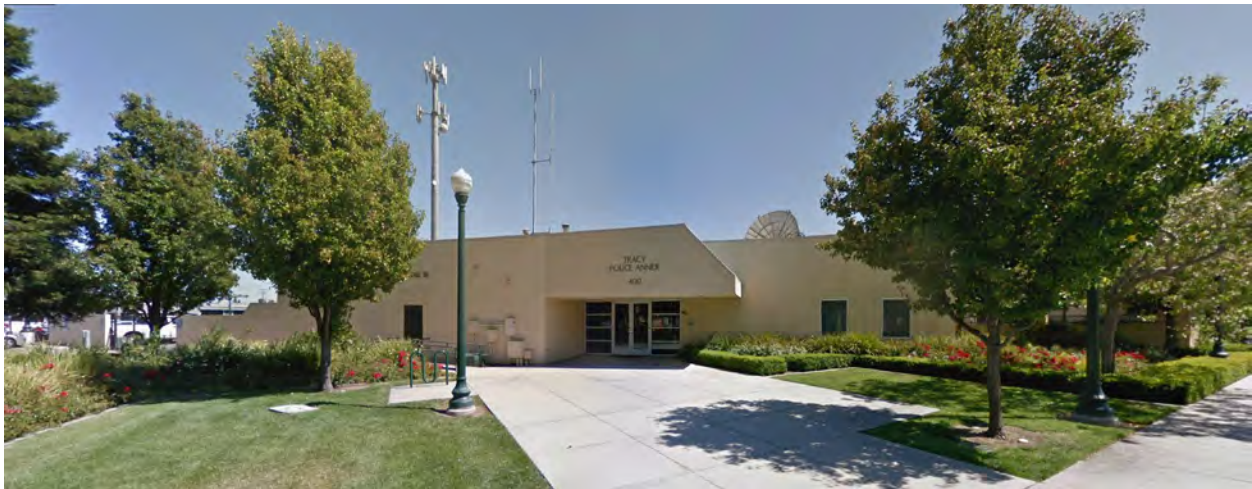
**Figure 34 - 1979 Tracy Police Building, 400 East 10<sup>th</sup> Street (to be demolished)**

In 1979, the Police Department moved into the newly built 9,800 square foot Tracy Public Safety Facility Building at 400 East 10<sup>th</sup> Street as part of the new Civic Center complex. This 1-story building included cast-in-place concrete partition walls for the 2,400 square foot jail. The department at this time consisted of less than 30 personnel. The condition of this 42-year-old building is poor.
