## NOTICE OF SPECIAL MEETING

**Staff recommends that City Council conduct a workshop to review the Citywide Public Safety and Public Facilities Master Plan Updates and provide feedback.**

The Citywide Public Facilities Master Plan (CPFMP) Update provides a comprehensive update to the 2013 CPFMP by evaluating the condition of existing public facilities and determining current and future public facility needs. The CPFMP Update includes facility condition assessments of all City facilities with recommended improvements for proposed new public facilities projects. Recommendations for renovations at City Hall, improvements and new facilities at the Boyd Service Center, and an expansion of the Community Center and Lolly Hansen Senior Center are provided as well.

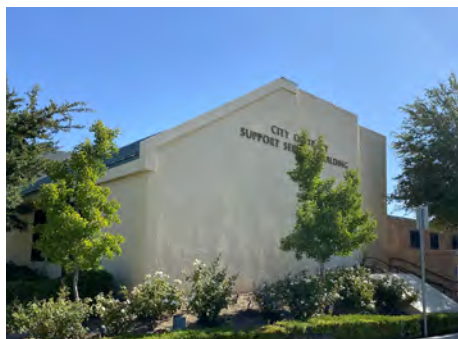
<p><b>Site</b></p> <p>The Support Services building contains healthy landscaping with plants and many trees. Concrete paving is in good condition with condition similar to the remainder of the Civic Center site. Some chipping is present at corners of landscape walls near main entrance. Support Services Trailer is located on site and contains additional offices for city employees. Crosswalk striping near entrance to Support Services building is faded and lacking due to asphalt chipping. Green site lighting units throughout the Civic Center site contain some paint deterioration and generally require cleaning.</p>	<p><b>3.8 Interior</b></p> <p>Wood door frames contain light splitting in areas and wooden window sills contain various levels of condition with some dry and deteriorating. Square carpet tiles and rolled carpet both hide stains well due to their dark color but don't give the interior a welcoming appearance and contain fraying and stains upon close inspection. Restroom floor tile is in fair condition with surface wear and staining present. Restroom surfaces generally contain out-of-date materials. A large scuff is present in floor length mirror in male restroom. Linoleum tile flooring in main building and trailer is in fair condition with much scratching and some chipping at seam areas. Rectangular acoustic ceiling tiles in main lobby and workspace area contain minimal signs of staining. Acoustic ceiling system grid of Support Services Trailer appears out of plumb in areas with tiles not placed properly and components protruding at odd angles. Gate separating reception from staff area is in poor condition with chipping at edges and discoloration at top due to frequent operation. Some staining is present at lighting lenses at Support Services Trailer.</p>

<p><b>Exterior Envelope</b></p> <p>Painted stucco siding of main facility is in similar condition as the remainder. Tin roof of Support Services Trailer is dirty with deteriorating rubber seals. Window grate screws at trailer are rusted. Exterior metal double doors leading to lobby are scratched at bases but operate smoothly. Built-up roof system is fair condition with deteriorated seams and bubbling surfaces in areas especially near rooftop drains. Drains themselves are blocked by a considerable amount of debris buildup. Staining due to water ponding is present in areas. Windows are believed to be single paned in most areas of the facility with tinting peeling off from lower interior covers of many glass surfaces.</p>	<p><b>3.4</b></p>
<p><b>Structure</b></p> <p>Moderate cracking exists at CMU wall structure for emergency generator on site. No major structural deficiencies were visually observed.</p>	<p><b>3.2</b></p> <p><b>4.0 MEP Systems</b></p> <p>Metal enclosures surround rooftop mounted MEP equipment are in good condition along with metal roof parapet. Main electrical service is served to the building through two 1000A Siemens switchboards manufactured in 2008. These should contain much remaining service life. Water heater was installed in 2006 and is likely nearing the end of its useful service life. Hinges on gate for access to transformer T-1198 are rusted. HF-125 extinguishing system is present for IT components with no reported use or problems. A Kohler diesel powered</p>

**Site:** Recommendations include repairing chipping at corners of landscape walls near main entrance, repairing asphalt chipping and repainting crosswalk striping, and cleaning green site lighting units.

**Exterior Envelope:** It is recommended to replace rubber seals of tin roof at Support Services Trailer, clean tin roof, replace window grate screws at trailer, repair multiple aspects of built up roofing system, clean drains of buildup, and reapplying tinting from lower interior covers of many glass surfaces.

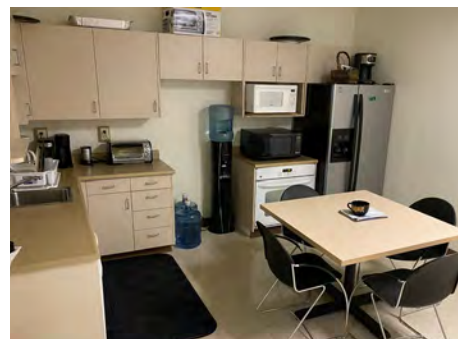
Kitchen

Interior break areas are not compliant due to counter height dimensions and lack of knee space.

**ADA Compliance:** Recommendations include increasing counter height dimensions and providing knee space in break areas.

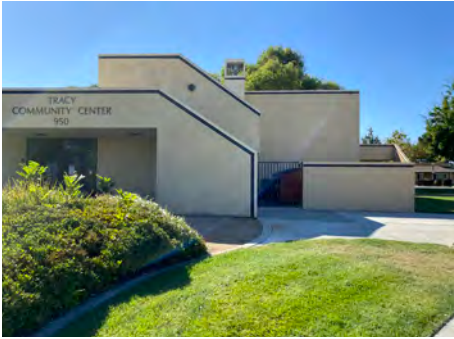
The exterior of building at electrical room is damaged at the door and exterior wall. TPO roof surface is in fair condition with no major signs of deterioration or surface uprising, but is stained with worn surfaces especially at areas of maintenance use and water ponding. Peaked metal roof portions are faded from sun damage and starting to rust at where lower edges of roofing panels meet flashing. Double entrance doors at lobby are in generally good condition with light scratching at paint. Roof access ladder is mounted securely to wall in table and chair storage area. Some rooftop elements including

exhaust fans contain rust. Roof drains are cracked. Windows are single pane and in good to fair condition with tinting that is not yet peeling but windows require cleaning. Exterior stucco is deteriorating at base of roof area and ground level and dirty areas under upper roof parapet.

**Exterior Envelope:** It is recommended to repair damage portions of wall and door, clean TPO roof surface at areas of maintenance use and water ponding, replace faded and rusting portions of peaked metal roof, clean rusted roof elements, repair roof drains, replace single paned windows, and repair exterior stucco at base of roof area and ground level.

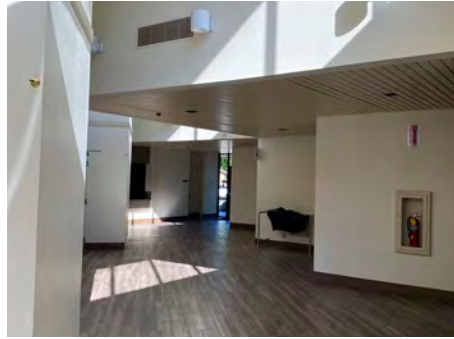
The main Community Hall is in good condition with recently renovated elements including flooring. Ceiling acoustic tile surfaces are in visually good condition. Flooring tiles are missing at entrances to some storage areas nears the main hall with exposed flooring adhesive present. Wall paint is scuffed and peeling in these storage areas. In general, storage area for chairs and tables is unfinished with damaged flooring, wall and ceiling elements. Concrete flooring in conference areas is in fair condition with moderate scuffing and cracking but shines nicely with no significant deterioration. Scratches on other wall surfaces are present. Acoustic ceiling tile is outdated and discolored in the main hall space. Kitchen equipment has served the facility well with signs of wear such a deteriorated stove top burners. Stained grout is present at ceramic tile flooring in kitchen. Metal ceiling system at lobby is in good condition with minimal signs of wear which include paint chipping at edges. Lobby baseboards are torn in a few places. Components of snack serving window and room are unfinished at interior. Restroom tile flooring is stained in high use areas.

**Interior:** Recommended actions include adding missing floor tiles at entrances to some storage areas, repainting walls in storage areas, generally renovating these areas to produce a more finished appearance, and fixing scratches on other wall surfaces. Additionally, recommendations include replacing acoustic ceiling tile, replacing stove top burners, cleaning grout at ceramic tile flooring in kitchen, repairing lobby baseboards, finishing components of snack serving window and room, and cleaning restroom tile flooring.

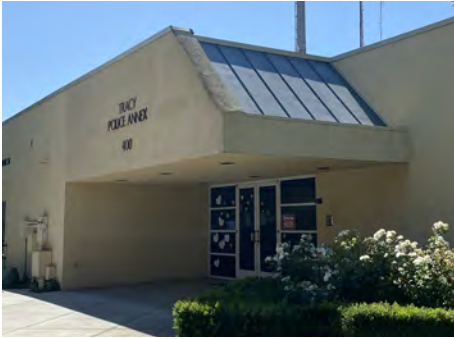
Painted concrete masonry exterior is faded and chipping in areas, especially where items are mounted on the exterior. Stucco is chipped and deteriorated in some areas. Mounted light fixtures contain discolored lenses and finish due to weathering and age. Exterior door sills contain no protection in many instances. Garage door opening to rear parking area is damaged with scratches and dents. Building signage is beginning to deteriorate and approaching its useful service life.

**Exterior Envelope:** It is recommended to repaint concrete masonry exterior, replace mounted light fixtures, provide protection for exterior door sills, replace garage door, and replace building signage.

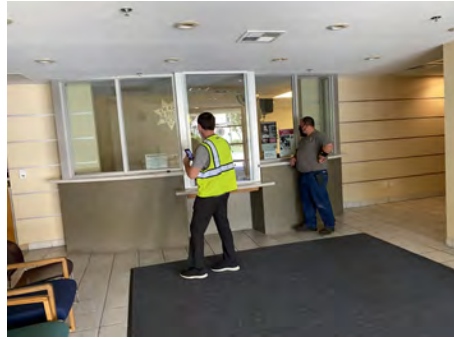
Lobby

investigation. Ceiling tiles are stained throughout the facility especially in conference areas. Wood doors have wear and are 20-min fire rated. Some door hinges have been replaced. Channel 26 room is somewhat crowded but in good condition overall. Carpeting is stained at the entrance to this area. Vinyl flooring in areas including kitchenette/break areas is scratched, bubbling, loose, or missing. At least one lighting fixture is hanging haphazardly below the ceiling system in kitchenette. Visible aspects of roof system are discolored and faded. Some restroom flooring tiles are cracked with stained grout. Lighting at public lobby near service center is severely lacking with standard incandescent bulbs in discolored and undersized recessed mounts. The roof was not accessible at the time of site visit.

**Interior:** Recommended actions include repairing and repainting metal doors in city jail space, adding lighting in same space, cleaning ceiling stains, and replacing ceiling tiles. In addition, carpeting should be cleaned, vinyl flooring should be replaced, lighting fixtures must be rehung, and lighting should be added in the public lobby with appropriate color and sizing.

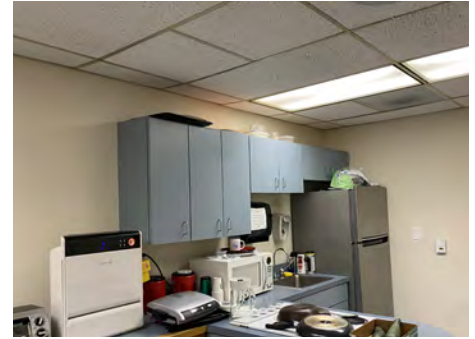
Break Room

Kitchenettes throughout the Police Annex are non-compliant due to lack of counter knee space and other items. Restroom accessories are non-compliant in some instances. Clear floor space in certain areas of the building is limited due to storage of items.

**ADA Compliance:** Recommendations include rebuilding kitchenettes to provide adequate knee space, relocating restroom accessories to be compliant, and clearing floor space to increase accessibility compliance.

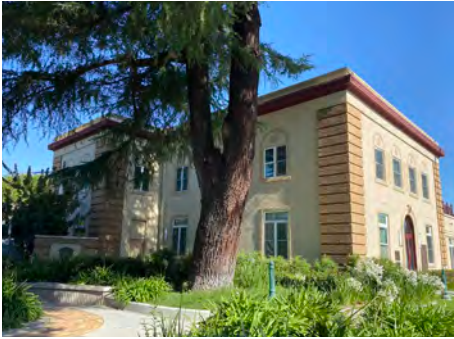
Exterior

Painted stucco exterior siding contains much cracking, mostly near ground surface but all throughout stucco surface including areas of cracking to roof parapet. Paint of various architectural components gives the facility a premium appearance but paint is starting to fade from exterior surfaces at most areas. Mounted gutters are in good condition with minimal denting and lack chipped paint. Mounted light fixtures contain faded housing and are adding to staining at stucco siding. Metal door are rear of building to parking lot is stained with faded paint and accessibility signage. Porch at second story overlooking Central Avenue requires cleaning at floor surface due to dirt and debris buildup. Skylight lenses are slightly dirty but tinting is holding up well. Garage door surfaces show no signs of deterioration. TPO roof surface is in good condition but stained and discolored in areas

Cracking in stucco surfaces throughout exterior of facility suggests that shifting of the structure may be happening at a more frequent rate than is standard. Additional cracking is present at interior at interior CMU construction and at door frames of MEP room which alludes to stucco cracking being in the concrete wall structure rather than just stucco deterioration. Cracking is also present painted walls in garage area, especially around window. Large fire protection piping is appropriately braced to walls and ceiling structure. Cracking is present at concrete flooring of MEP area.

**Exterior Envelope:** It is recommended to repair cracking throughout exterior, repaint exterior surfaces in similar areas, repaint metal door at rear of building, clean floor surface of porch at second story, and clean TPO roof surface.

**Structure:** Recommendations include assessing structural integrity of building and repairing all cracking in various locations throughout the building.

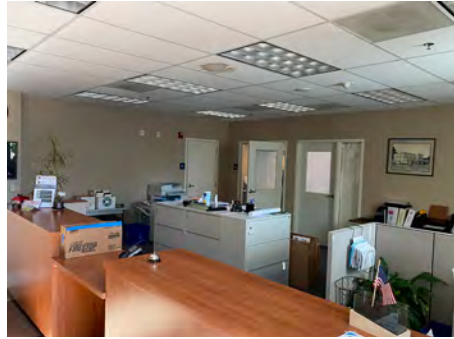
Lobby

Carpeting and vinyl flooring surfaces of living area contain minimal signs of wear with light scuffs at kitchen floor. Can lighting is detaching at painted ceiling in living area. Paint is chipped at corners of walls in living area. Vinyl tile flooring is well-polished throughout main facility areas but staining is present at seams under drinking fountain and in a few other areas including near baseboards. Break room flooring contains excessive wear compared with the remainder of the facility's vinyl flooring. Painted wood baseboards are dirty and heavily scuffed. Rectangular acoustic ceiling tiles contain grid components that are out of plumb in areas. Restroom tile flooring and other surfaces are in good condition and holding up well to use. Lighting types vary throughout the facility but are generally a type of recessed rectangular fixture. These fixtures are in fair to good condition with some lenses loose or discolored. A large stain is present on a singular acoustic ceiling tile near office spaces by public entrance and reception. Some wear is present at wooden gate

**Interior:** Recommended actions include cleaning light scuffs at kitchen floor, reattaching can lighting at painted ceiling in living area, repainting wall corners in same area, cleaning stains at seams under drinking fountain and baseboards, replacing break room flooring, and cleaning painted wood baseboards. Additional recommendations include cleaning and tightening light fixtures lenses and replacing singular stained acoustic ceiling tile by reception area.

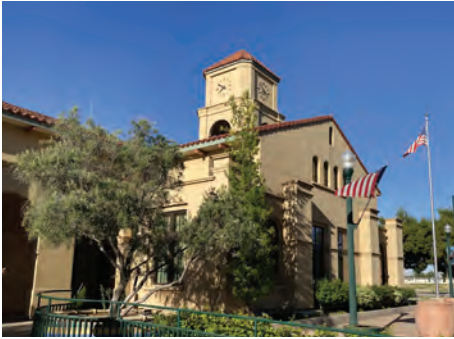
<p><b>Exterior Envelope</b> <span style="background-color: yellow;">3.7</span></p> <p>Exterior window frames contain chipping paint in multiple areas. Water marks are present below window sills at the exterior of the facility. Minor cracking has observed at exterior wall structure. Clay tile flooring adjacent to exterior entrances is generally in good condition but dirty. Clay roof tiles are in good condition overall but some contain chipping. Exterior doors and hardware are past useful service life with lots of scuffs and scratches present. Roof drains at access platform require replacement.</p>	<p><b>MEP Systems</b> <span style="background-color: yellow;">3.8</span></p> <p>Evidence of plumbing system leaks are shown by damaged ceiling tiles and toilets are showing leakage at bases. Water piping is present over electrical equipment in Room 109, a code violation. HVAC system requires upgrade and renovation to meet needs. Mechanical equipment is largely located on a platform near the clock tower. Roof mounted A/C units serve the conference room area. An 800 Amp main switchboard serves the facility well and located in the same area with fire alarm and Internet server equipment.</p>

**Exterior Envelope:** It is recommended to repaint exterior window frames, clean water marks below window sills, fill in cracking at exterior wall structure, clean clay tile flooring, repair chipped clay roof tiles, replace exterior doors and hardware and replace roof drains at access platform.

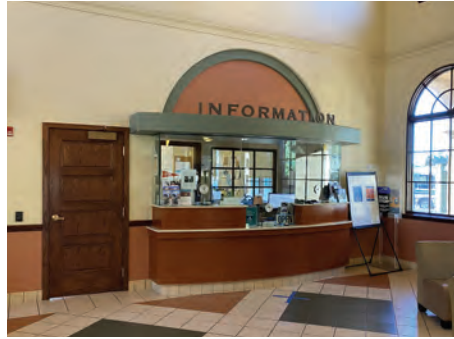
Lobby

<p><b>Structure</b> <span style="background-color: yellow;">4.0</span></p> <p>Minimal cracking is present at interior tile flooring in lobby. No structural cracking was observed at walls. Roof structure is in sound condition as observed visually. Minimal cracking present at exterior finishes. Roof structure contains cracking at parapets.</p>	<p><b>ADA Compliance</b> <span style="background-color: red;">Needs Compliance</span></p> <p>Truncated domes or other detectable warning are not provided appropriately at site and parking area. ADA parking stalls require flat pavement. Restroom signage is lacking in main hallway and some accessories are not compliant.</p>

**Interior:** Recommended actions include repairing minimal cracking at interior tile flooring in lobby, replacing vinyl flooring in storage areas, replacing carpeting in office areas, securing velvet transition strips, repairing all leaking in office area and all gender bathroom within ceiling system and modernizing restroom finishes.

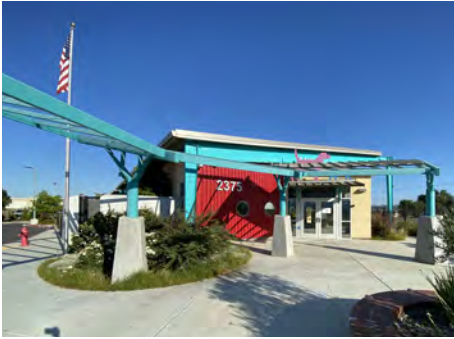
Exterior

The exterior of the Animal Shelter is in good condition overall. Multiple components are used for exterior façade elements and are holding up well. Some discoloration on exterior wall surfaces is present. Light cracking is present at top of exterior concrete security wall.

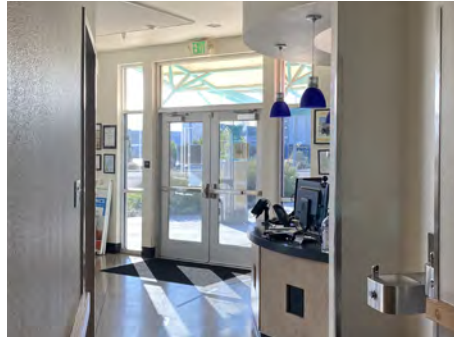
Lobby

Single door in lobby sometimes sticks and will not remain open or closed. Double doors in lobby area don't shut properly and requires significant effort to close and lock. The ground latch in this location requires maintenance and servicing. Stone flooring in lobby is in good condition. Concrete flooring is cracking in places in animal housing area. Terrazzo flooring around reception desk has slight wear. Guillotine doors break often at animal housing area and require frequent maintenance to pulley operation system. Flooring in laundry area is dirty and worn with rusting around laundry drainage. Grooming area flooring requires cleaning and holding area flooring is scratched. Window seats have come loose in multiple areas. Floor drainage in animal cleaning areas is in good condition. Attic contains no roof access. Sink wood is worn in "CAT ISO" area.

**Interior:** Interior spaces would benefit from repairing lobby single door to remain open and closed, replacing locking system on double doors in lobby, servicing the ground latch in lobby, and repairing cracks in concrete flooring in animal housing area. Additionally, it is recommended to replace guillotine doors, replace flooring in the laundry area, clean holding area flooring, tighten window seals, provide roof access for attic, and replace sink counter carpentry in "CAT ISO" area.

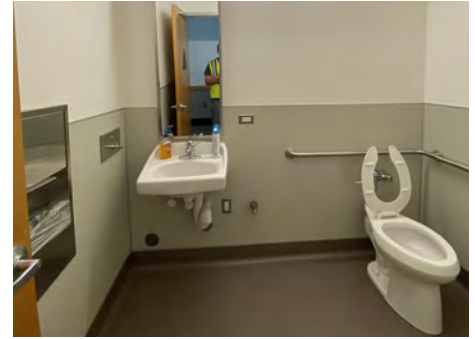
Bathroom

Light cracking is present at soffit of women's restroom. Equipment attachment and supports for laundry machines are not being utilized. Ductwork and cabling above ceiling appears to be appropriately braced.

Various elements of animal intake and housing operations aren't ADA compliant. Restrooms contain minor fixtures violations.

**Structure:** It is recommended to repair cracking at soffit of women's restroom and utilize non-structural seismic hold downs for laundry machines.

**ADA Compliance:** It is recommended to reconfigure various elements of animal intake and housing operations areas to be made compliant. Minor changes to restroom fixtures are required.

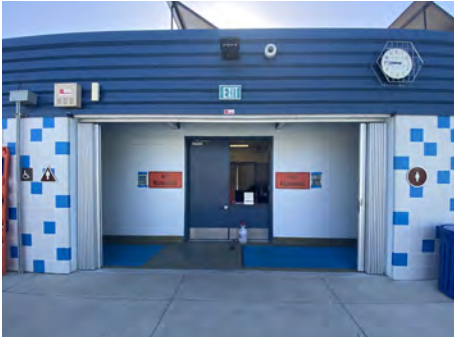
Exterior tile wall finish is slightly stained at tile in areas but grout is holding up well and only discolored at areas where other items are mounted on the wall. Roof drainage includes gutters that are exposed only at the exterior fascia and are clogged with leaves in areas. Metal fascia at top of exterior walls is discolored with a finish and paint that is beginning to deteriorate at joints and flat surfaces. Exterior entrance to locker room doors are folding and aluminum and show no signs of wear. Signage is in good condition and serves the facility well, but requires substantial cleaning. Exterior windows are present at a small number of areas including the food service window at the kitchen.

**Exterior Envelope:** It is recommended to clean out gutters and to paint metal fascia and re-grout some exterior tile.

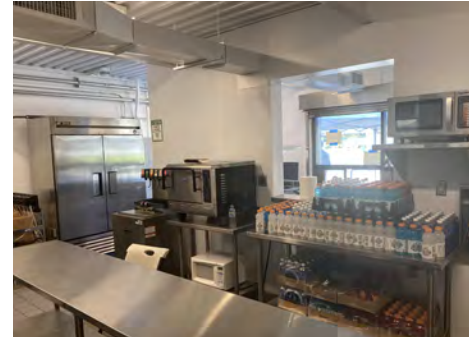
Interior lighting is in good condition and largely LED tube lighting throughout. Brown tile flooring in kitchen area has stained grout in the center of the kitchen and in areas under heavy-use appliances. Ceiling kitchen is exposed corrugated metal with a clean painted finish. Kitchen appliances are largely stainless steel and contain significant remaining useful service life. Smooth wall finished in kitchen appears freshly painted with no cracking or staining. Locker room walls are finished in similar painted concrete blocks as pump room but are more stained and discolored at both block surfaces and grout. Ceiling systems in this location are similar to the kitchen but discolored and stained in areas likely due to moisture buildup from shower steam. Restrooms are finished in stainless steel and serve the facility well under heavy use. Epoxied flooring in restrooms and locker rooms is in good condition with minimal surface wear. Tile wainscot is similarly maintained with minimal staining. Roll up metal doors in lock room areas are well-maintained with no obvious visual signs of deterioration. Shower walls and flooring are finished in tile that appears to be holding up well. Minimal staining is present at shower floor tile and grout which is to be expected. The interior of locker rooms and showers has an area under the roof that is fully exposed to the outdoors, which greatly increases ventilation with no effect on privacy.

**Interior:** Recommendations include replacing tiling at kitchen flooring, repainting concrete blocks and grout in locker room walls and updating lighting system at reception.

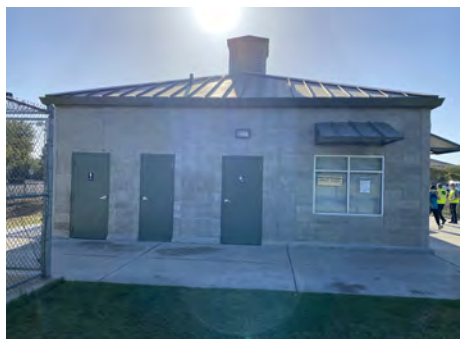
Exterior

Roof surface is in good condition but requires cleaning due to dirt and grime buildup. Awning have similar dirt buildup especially at areas near roof eaves. Concrete block siding is in fair condition with spotted chipping and cracking at all sides. Staining is also present at exterior siding. Aluminum entrance doors are in good condition with much remaining service life but lock sets are dirty and contain fading green paint and rusted hinges. Exterior-mounted lighting fixtures contain discolored housings and overly yellowed lenses. Aluminum window frames are discolored and worn. Gutter paint finish is fading but no major denting or attachment issues were observed besides cracked material leading gutter ends into grand drains. Sealants at door thresholds at main restrooms and generally around the building are cracked and deteriorating. Awning surfaces are worn on the undersides.

**Exterior Envelope:** It is recommended to clean the roof surface, fix small cracks and paint chipping, clean exterior siding, replace lock sets of aluminum entrance doors, and replace exterior-mounted lighting fixtures. Other recommended actions include resealing sealants at door thresholds at main restrooms and replacing awning surfaces.

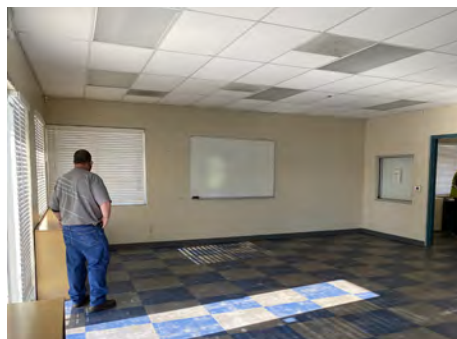
Interior vinyl tile flooring is nearing the end of its useful service life with lots of scuffing and discoloration throughout. Interior doors have worn surfaces. Ceiling system is in poor condition with acoustic tiles that are plumb and not yet discolored with signs of staining in utility closet. Light fixture housings are slightly discolored and stained in places. Interior CMU walls are discolored and would benefit from a repainting. Baseboard is not properly attached in places.

**Interior:** Improvements should include replacing interior vinyl tile flooring, resurfacing interior doors, replacing the ceiling tile system, repainting interior CMU walls, and reattaching baseboard in places where it is loose.

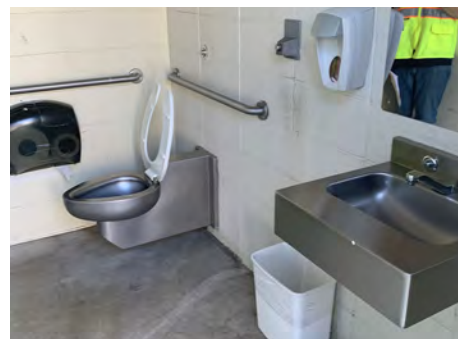
Bathroom

Main restroom fixtures are largely non-compliant including toilet flush button. However, ADA compliant restrooms are located with exterior access at the rear of the facility adjacent to the fields. Accessibility signage at parking lot asphalt surface is worn beyond recognition.

**ADA Compliance:** Recommended actions include replacing and relocating main restroom fixtures and replacing accessibility signage at parking lot asphalt surface.

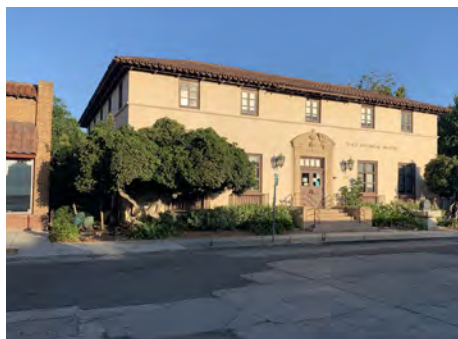
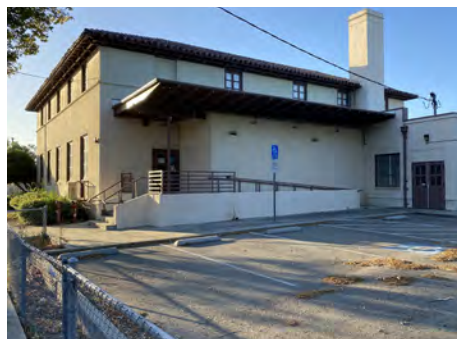
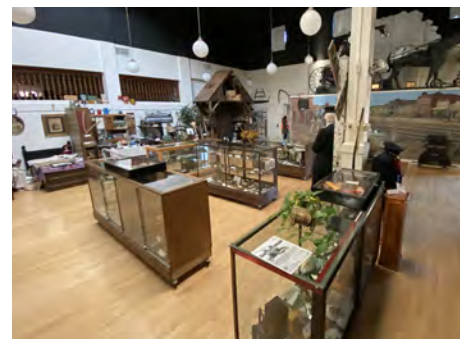
<p><b>Site</b></p> <p>Parking lot pavement is in fair condition with signs of light deterioration and striping that is beginning to fade. Landscaping is healthy overall but weeds are growing adjacent to parking lot fencing, some plants are dry and areas of open dirt are present. Major cracking is present at main entrance steps on Adam Street. Slight cracking is present at steps from rear parking area. A short sliding gate adds minimal security to the parking area and contains a rusted wheel mechanism. Exposed top of metal fencing at sliding gate is damaged in multiple areas. Flagpole is in good condition but requires cleaning. Curbing at Adam Street side of site is cracked and deteriorated and damage continues into street.</p>	<p><b>2.8 Structure</b></p> <p>present.</p> <p><b>3.1</b></p> <p>Patched up cracking on the ceiling within small display room suggests structural issues. Large crack is present from door frame to ceiling in storage room. A major structural investigation should take place to assess the facility's structure. Other than cracking in places, no significant structural shifting was visibly present. However, an investigation should take place due to the facility's 1916 construction date.</p>

<p><b>Exterior Envelope</b></p> <p>Painted concrete exterior envelope is generally in fair condition with surface discoloration in areas and light cracking present. Paint chipping is present in window frames. Exterior lighting fixtures are outdated and dirty due to cobwebs and other debris. Stucco at exterior and stair siding requires intensive cleaning and in some cases new paint. Roof parapet is not flush in places and some clay roof tiles are loose, chipped or missing. The underside of the roof overhand requires new paint. Roof surface itself requires intensive cleaning and new sealant in areas. Skylight windows are single pane and serviceable from roof and contain rusted frames. Drainage elements are rusted and clogging evidence and ponding water are both present around drains. Entrance door at rear near parking lot requires replacement. Main entrance doors require replacement or new paint. Decorative window balconies are rusted in places and require new paint at minimum. Single pane windows are</p>	<p><b>3.3</b></p> <p><b>Interior</b></p> <p>Stains and discoloration on suspended ceiling tiles suggest leakage from the second floor. Tiling throughout museum is in good condition with signs of wear and discoloration. Wood flooring throughout main level of interior is scuffed, scratched and contains misaligned floorboards in places. Tile flooring near Holly Sugar display requires cleaning. Carpeting at second floor is in good condition but transition strips and tile grout around these areas require replacement. Elevator is in serviceable condition with remaining service life but sills require intensive cleaning. Finished in restrooms are in good condition.</p> <p><b>3.4</b></p> <p><b>MEP Systems</b></p> <p>HVAC systems are in good condition. Leaking from restroom upstairs restroom should be repaired. Rooftop HVAC equipment is nearing the end of its useful service life and would benefit from replacement. Water lines going to AC units are rusted. Fire water access is provided on-site but access valves require painting and new signage due to rust and paint deterioration. Exit signage is required to be illuminated.</p> <p><b>3.5</b></p>

Stair and ramp handrails at front and rear of building are not ADA compliant as handles are square and do not provide 12" flat surfaces at landings. Truncated domes are not present. General sidewalk slope is not ADA compliant. An elevator is present. Some issues are present related to accessibility due to lack of clear floor space. ADA compliant stall in men's restroom is being used as storage which hinders the 5' turnaround requirement. Paper towel dispenser is protruding. Marble Transition Strips are not compliant. Clear floor space is not provided under kitchenette sink. Interior stairway handrails are non-compliant. Upstairs restrooms are not ADA compliant and contain old fixtures and finishes.

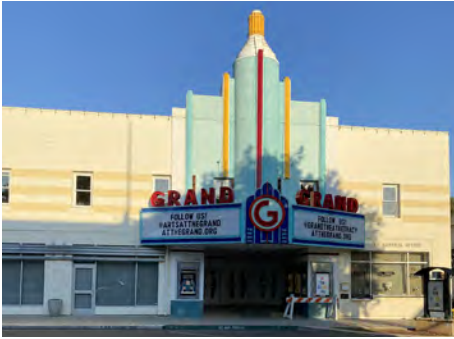
Exterior

The downtown area site serves the facility well. Some cracking is present at exterior site curbing and cracks at pavement exist throughout. Sidewalk surrounding the facility is finished in large tiles that are in good condition with minimal signs of staining or wear. The alleyway used for deliveries and production access contains surface paving in poor condition.

**Site:** Recommendations include repairing cracking at exterior site curbing, and re-surfacing alleyway.

**Exterior Envelope:** It is recommended to modernize exterior signage, add exterior lighting, and replace the large metal door at the alley area including track components.

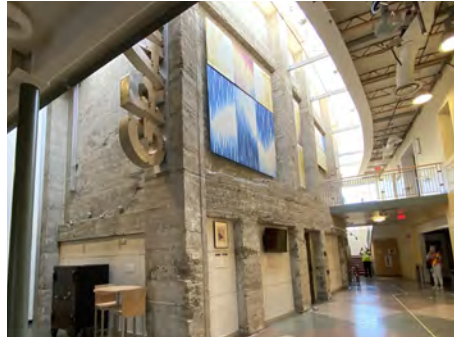
Lobby

Handrails throughout the lobby are non-compliant due to very minor dimensional violations. Truncated domes at the entrance to the facility are present at the downtown area leading to other areas of downtown. Some work areas are non-compliant due to storage spaces covering open floor space area.

**ADA Compliance:** Recommendations include making minor dimensional fixes to handrails throughout the lobby and clearing floor spaces in work areas.

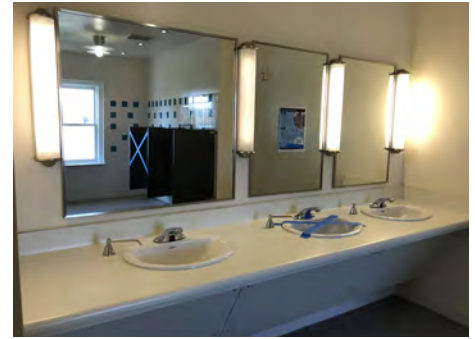
Bathroom

store is stained in high traffic areas. Tile Restroom Floor at 2nd story contains stained grout. A significant crack exists from the Art Gallery to the Dance Studio in decorative flooring, and the same anomaly occurs at the main lobby near the foyer.

**Interior:** Recommended actions include realigning ceiling tiles, replacing worn seats at the theater, reapplying sound deadening material at the stage area, maintaining the Studio Theater accordingly, replacing VCT tile in restroom, replacing ceiling tiles in Gallery Workroom and cleaning grout in tile flooring in the art store and restroom floor at the 2nd story.

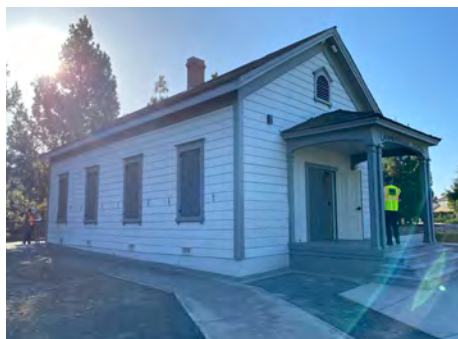
Exterior

No parking to the Lammersville School is provided. Canopy posts at exterior sign contain rot at bases on both sides and paint is flaking from signage. Ground cover directly adjacent to the building consists of dirt and dry tan bark and would benefit from some renovation. Sidewalks contain minimal cracking.

Wooden floorboards at porch and ramp are cracked and deteriorating in places. Evidence of wood rot is present at some areas along with excessive paint chipping on wooden boards and building wood siding. Wood paneling is missing at door frame base. The building requires complete repainting. Roof shingles are in poor condition and showing various levels of separation from roof surface and membrane. Gutters and downspouts are not provided.

**Site:** Recommendations include the addition of a parking lot, replacing rotted canopy posts, repainting canopy post signage, and cleaning and maintaining the ground cover directly adjacent to the building.

**Exterior Envelope:** It is recommended to repair damaged wooden floorboards at porch and ramp, and repaint both the wooden board and the entire exterior envelope. Roof shingles should be replaced and gutters should be included.

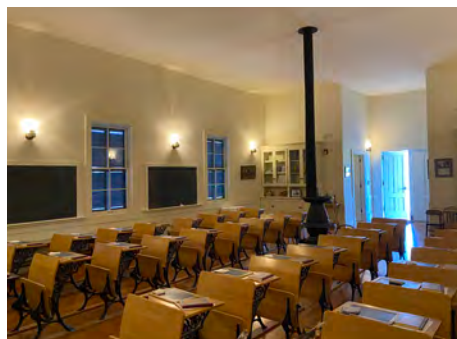
Classroom

Wood flooring at entrance (high traffic area) is scuffed and discolored. Historical elements showing the history of Lammersville School are largely present. The ceiling is finished in plaster and painted white. All lighting is wall mounted. Single pane vertically-sliding windows are found throughout.

**ADA Compliance:** Recommendations include the addition of handrails at stairs, moving furniture to allow an accessible path of travel, and adjusting mounting heights for interior accessories to meet compliance requirements.

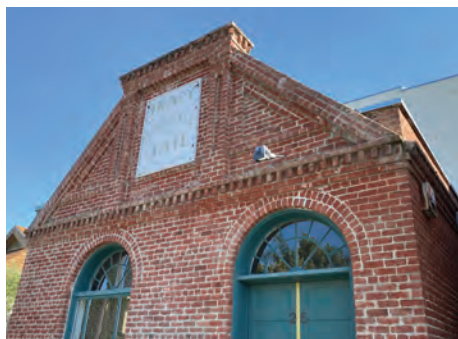
The exterior masonry facade is in adequate condition for its age but shows signs of fading, crumbling and other deterioration. Along the bottom of the front, and concentrated on the right of the door is quite discolored and would benefit from cleaning and repainting. Tracy Town Hall and Jail sign is severely faded and rusting through in places. Most of the window frames need to be repaired or repainted. Exterior mounted alarm box is rusted.

**Exterior Envelope:** It is recommended to apply historical preservation measures to the exterior and renovate the sign. Replace window frames where required and paint others. It is also recommended to repair cracks on window sill.

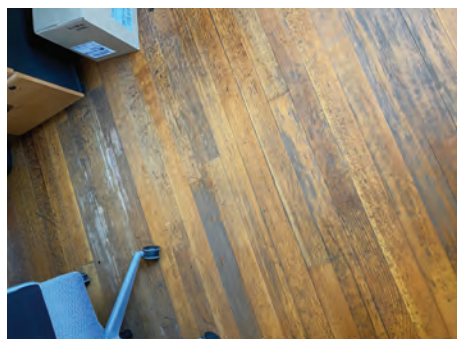
Interior Flooring

Hardwood floor finishes are worn throughout the building especially in high traffic areas. Wall and ceiling paint finishes are in good condition. Ceiling crack is present near the corner by the passageway to restroom. Furniture is in fair condition with light scratching on some surfaces. Finishes within restroom would benefit from modernization in general. Cabinets within the restroom do not have proper doors.

**Interior:** Improvements should include refinishing hardwood floors, repairing crack in ceiling, modernizing the whole restroom, and refinishing the storage room walls.

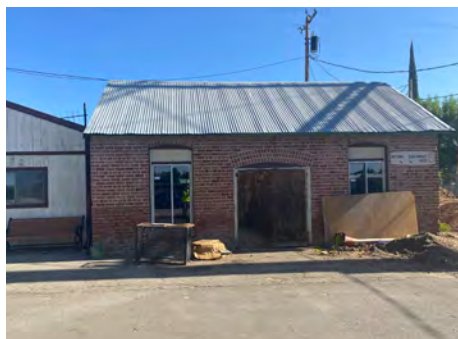
The exterior of the maintenance building is historic masonry construction that is in fair condition for its age with slight chipping of bricks in places and grout that has cracked and deteriorated especially near the bottom of the structure. Entrance doors to the maintenance building are rotted wood and contain frames with paint chipping to the extreme. Windows are horizontally sliding and single pane and appear to be in fair condition and installed sometime after construction. The metal roof structure is slightly bent in places and contains no gutters although no leakage was reported. The exterior of the adjacent office building has painted wood siding that is chipping throughout. Exterior bolts and metal are rusting through paint coatings. Door hinges are rusted.

**Exterior Envelope:** Recommendations include replacing rotted wood entrance doors, adding gutters, improving the bent metal roofing structure, repainting the wood siding, and replacing rusted exterior bolts and door hinges.

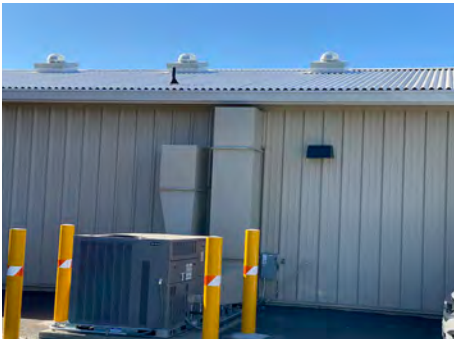
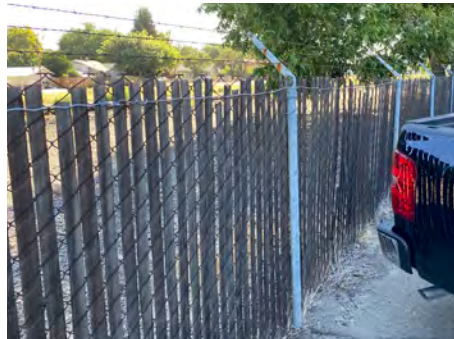
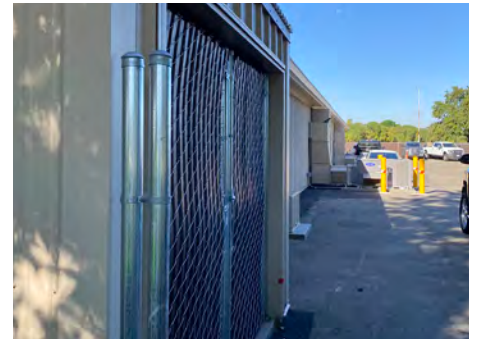
3.9</p> <p>Asphalt paving for the Building B parking area is cracked in multiple places throughout. Heavier cracking is present closer to the building. Painted striping for parking stalls is generally faded throughout the parking area. Staining is apparent at parking stalls closest to brown gate on site. In the same area, there is a small accumulation of leaves and dirt. Landscaping is minimal but appropriate for the site. Fencing around the perimeter is nearing the end of its service life in some places.</p>	<p><b>Interior</b>

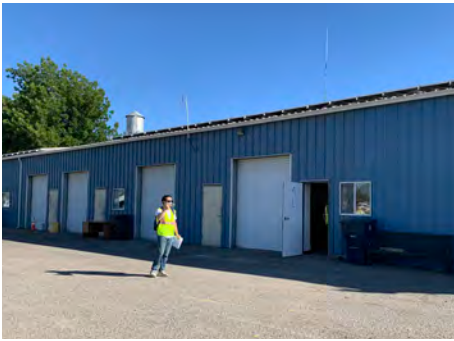
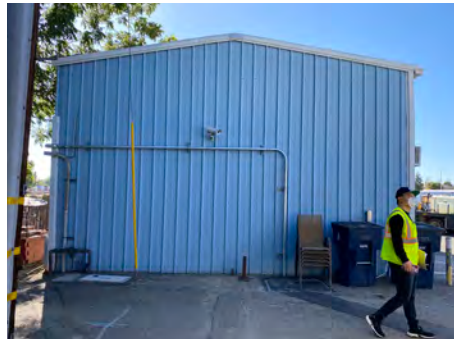
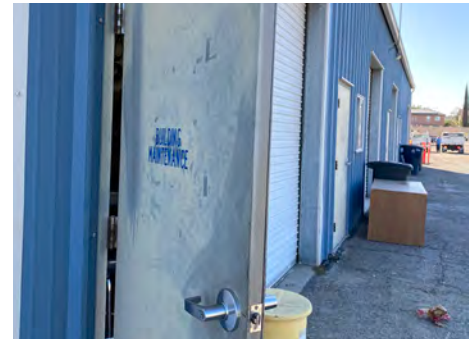
Asphalt paving has signs of cracking throughout the parking lot. Asphalt is discolored at garage door openings of the building. Striping is fading at parking stalls and other locations near the building. Paving is slightly uneven at the side of the building in two locations. Alley behind the maintenance shop is unpaved and is loosely used as an outdoor storage space. Objects and other debris are scattered throughout the area. The space is not easily accessible and could benefit from a repavement.

In general, exterior envelopes of buildings at Boyd Service Center are painted metal buildings with metal roofs and interior steel structures. Siding of the maintenance shops is in fair condition and is fading slightly in some areas and slightly discolored in other areas. Door signage is significantly faded and must be redone. Doors are also discolored from dirt and dust. There is a decent amount of lighting present on the exterior side of the building but fixtures are outdated.

Interior light fixtures and ceiling grid systems freely hung from the maintenance shops ceiling may require additional non-structural seismic lateral and longitudinal support. Cracking exists at various locations of the concrete floor.

Concrete flooring of Building C is cracked and stained in places. Acoustic ceiling tile of this same building contains many stains from leaking plumbing. Some acoustic ceiling tiles have minor cracks, visible in the corner tile by the garage door. Tube light fixtures provide an appropriate amount of light into the interior spaces.

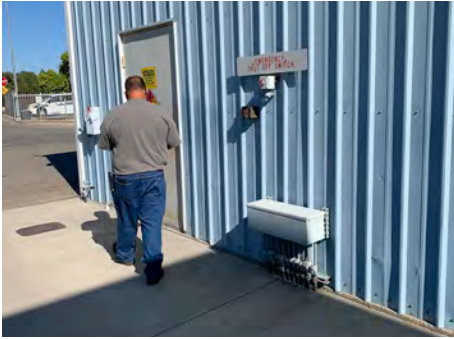
<b>Site</b> Asphalt paving around the Warehouse Building is cracked in places. No landscaping exists around this building. Site lighting is lacking at this area.	<b>3.6 Interior</b> Entrance door at interior is very scuffed and dented especially at interior base. The remainder of the interior is generally well-organized and in fair condition.
<b>Exterior Envelope</b> Exterior siding and doors at Building D contain faded paint and rusted screws. Roofing is in relatively good condition with no signs of rust but drainage would benefit from the addition of gutters and downspouts. Exterior lighting fixtures are present only above entrance to storage warehouse.	<b>3.5 MEP Systems</b> No major MEP deficiencies were observed.
<b>Structure</b> The structure of Building D is in visibly good condition.	<b>3.3 ADA Compliance</b> Interior stairwells at the Warehouse Building are not compliant. Other elements of the interior are not compliant.

**Site:** It is recommended to repaint site striping and eventually repave site.

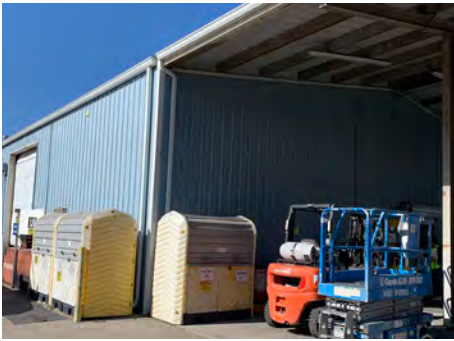
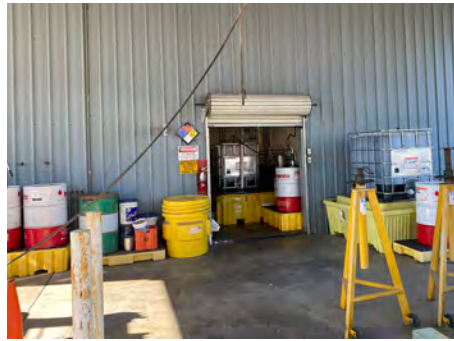
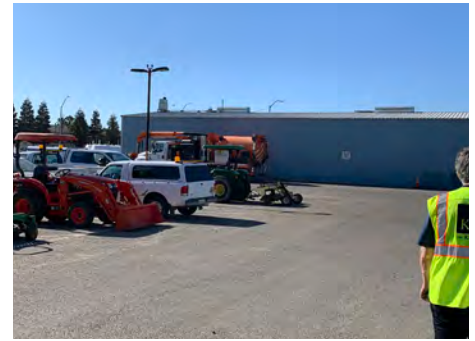
<b>Site</b> Asphalt paving around the Vehicle Fleet Shop is cracked in places. No landscaping exists around this building. Site lighting is lacking at this area.	<b>3.6 Interior</b> The interior of Building E contains concrete flooring in fair condition with signs of wear and deterioration. Interior equipment related to vehicle maintenance is generally in good condition but undersized. Restroom flooring inside Building E is stained with tiles in various states of deterioration.
<b>Exterior Envelope</b> Exterior siding of Building E contains faded paint and rusted bolts in areas. Overhead vehicle doors require replacement. Roofing is in fair condition. Exterior lighting is lacking	<b>3.5 MEP Systems</b> Exhaust and ventilation system requires improvement for operations. Interior lighting is lacking in places.
<b>Structure</b> Exterior overhang area contains rusted structural elements.	<b>3.3 ADA Compliance</b> <b>Needs Compliance</b> Building E contains a non-compliant second story loft area used for offices. Restroom in Building E is also non-compliant.

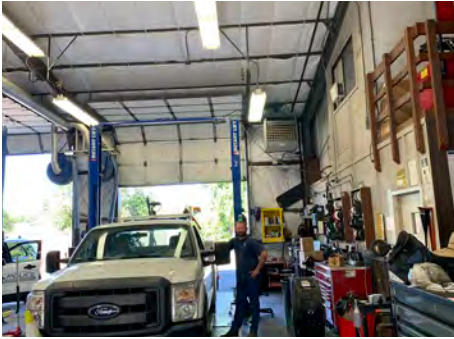
4.2.E: Concrete flooring at shop contains major cracking and faded striping.							
	4.3: Interior walls are covered in grease and grime with areas of chipping or faded paint.

**Interior:** Repair concrete flooring and replace interior stair system with ADA compliant second story access.

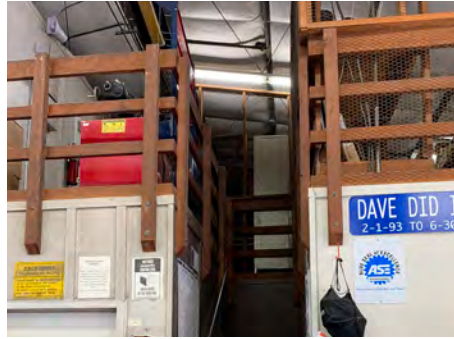
Loft

4.4: Interior doors are stuffed with fading paint.							
	4.5.A: Interior stairs are exposed wood with signs of rot and other deficiencies.							
	4.5.B: Interior stair handrails consist of an undersized metal pipe.

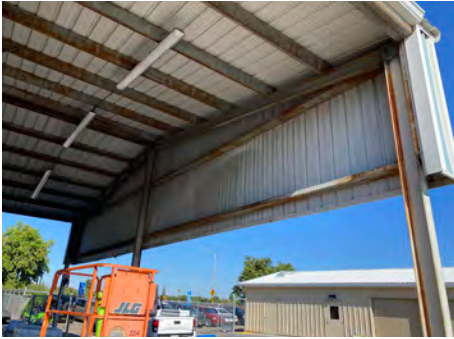
Overhang

3.3	Framing System							1.0
3.4	Walls							3.0
3.5	Lateral Force Resistance System							3.0
3.6	Covered Walkway/Canopy							N/A
3.7	Chimney							N/A
N O T E S	3.3: Large amount of surface rust is present at exposed framing system in covered equipment storage area.

**Structure:** Replace rusted structural components of exterior exposed bay.

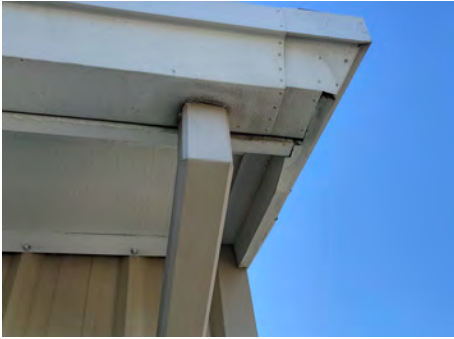
Gutter

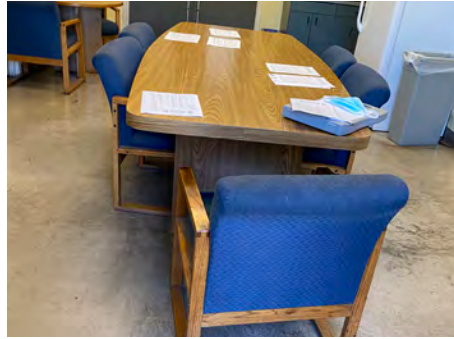
Interior

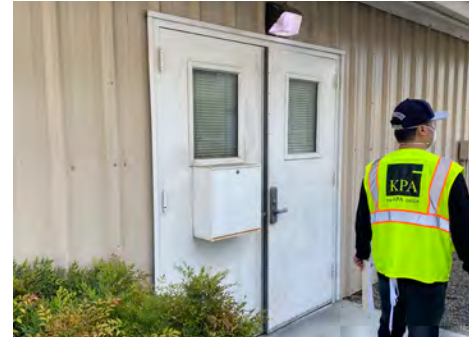
Exterior

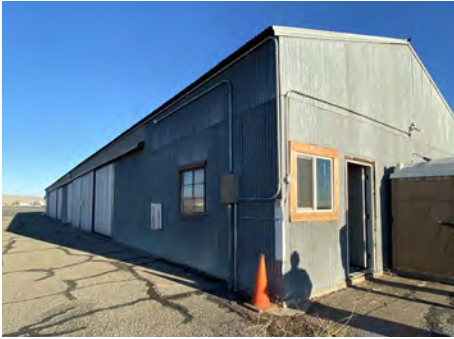
Light rusting is present a metal exterior panel edges. Gate tracks are rusted and often bent out of plumb. Waterproofing elements at bases of doors differ among hangars. Single pane windows are present at the Airport Operations office. The office paint is in good condition overall with no signs of chipping. Door frames are exposed wood with splitting and discoloration. Single plane window frames contain splitting wood frames and chipping paint throughout. Wood window sills are similarly deteriorating. Roof surface is rusted and out of plumb.

Exterior

**Structure:** Repair or replace rusted structural elements.

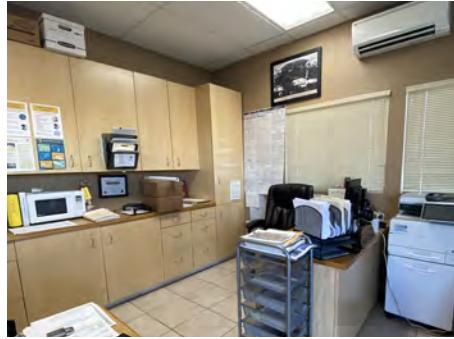
Interior of the 3 series hangars largely consists of exposed redwood structure. Concrete flooring contains minimal cracking. Airport operations office has worn carpeting and contains an acoustic tile ceiling.

Office

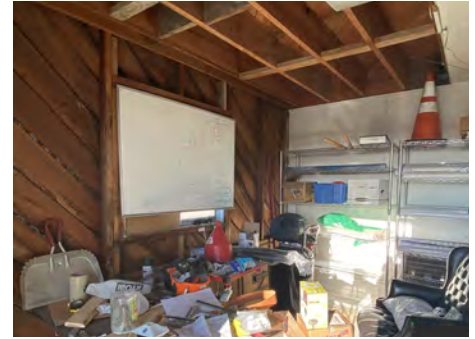
Storage

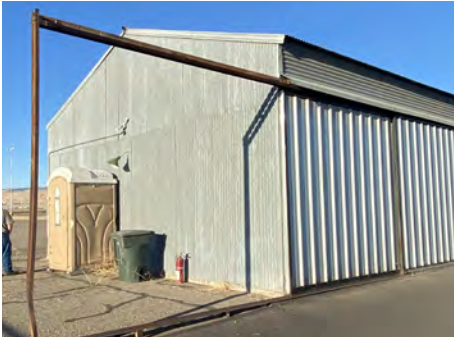
Exterior

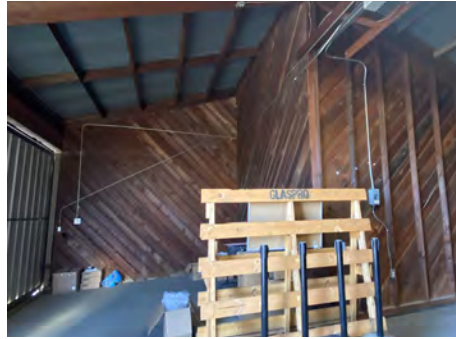
Interior

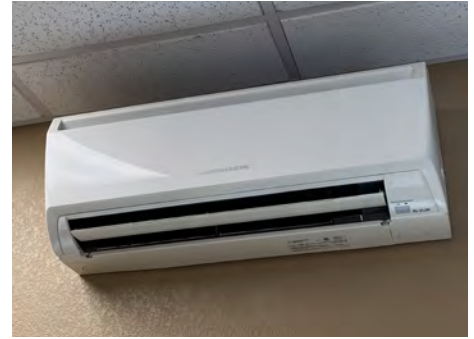
Lighting controls are present at hangars. Vents have been created in the ceiling of Airport Operations office to reduce the popping noises due to wind. Electrical junction boxes containing circuit breakers are mounted to hangar exterior with exposed conduit in fair condition. Minimal rusting and deterioration is present at exposed conduit joints.

MEP

**MEP Systems:** Install water line for use at 3 and 4 series hangars. Replace rusted conduit at exterior.

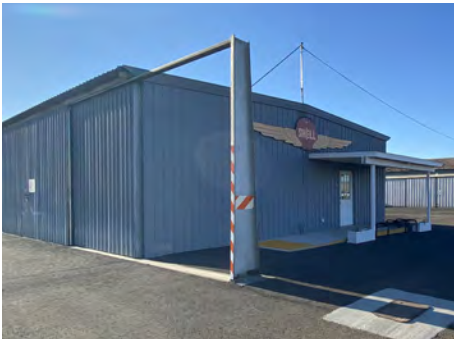
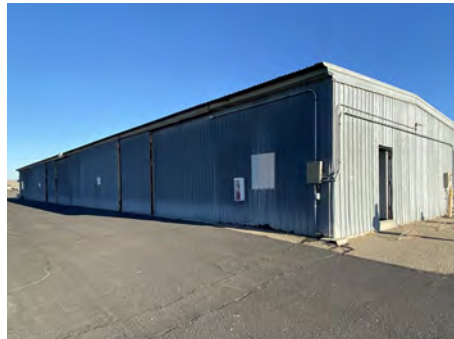
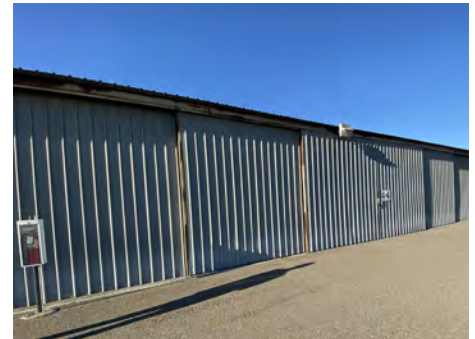
The exterior metal siding contains chipping and worn paint throughout. Metal roof is in fair condition with no reports of frequent leaks. Painted signage identifying individual hangar numbers is faded and scuffed.

Main metal structural elements are quite rusty including the siding of sliding hangar doors and at steel structural framing in interiors. Walls are visually plumb.

The Pilot's Lounge is located in the 4 Series Hangars. Flooring in Pilot's Lounge is in poor condition with many gaps in the finish. Patched drywall is present at multiple locations. Interior lighting is fluorescent lacking and would benefit from an upgrade. Doors at the interior contain various types of locking mechanisms.

An exterior mounted transformer rated at 208 Y/120 is located adjacent to the 4 Series Hangars that serves both the 3 and 4 series hangars. There is no water line available for use to the 4 series hangars. Conduits with junction boxes are mounted to both the exterior and interior structures and are in fair condition with some rusting present.

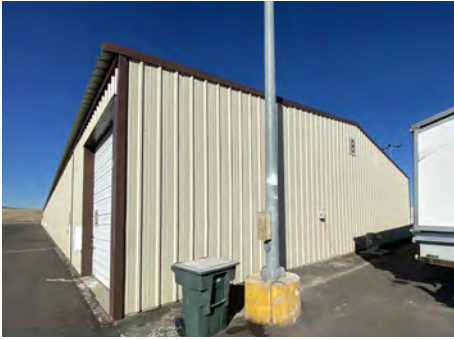
Exterior

<p><b>Site</b> <span style="background-color: #f4a460; padding: 2px 10px;">3.7</span></p> <p>Location of B-Series hangars is not ideal for airport maintenance staff as water drains toward the building that often causes tenants to construct makeshift elements to prevent water intrusion. The City must remove these elements at a later date.</p>	<p><b>Interior</b> <span style="background-color: #fff9c4; padding: 2px 10px;">4.0</span></p> <p>Staining from oil and other airplane engine fluids is present at interior concrete flooring.</p>
<p><b>Exterior Envelope</b> <span style="background-color: #fff9c4; padding: 2px 10px;">4.1</span></p> <p>Exterior walls are in good condition and appear recently painted. Roof and mounted exhaust fans contain much remaining service life with no visual deficiencies observed or maintenance problems reported.</p>	<p><b>MEP Systems</b> <span style="background-color: #f4a460; padding: 2px 10px;">3.1</span></p> <p>Housing for exterior ground-mounted 3-Ph transformer is rusted.</p>

**Site:** It is recommended to move sites for these hangars to be more accessible and useful.

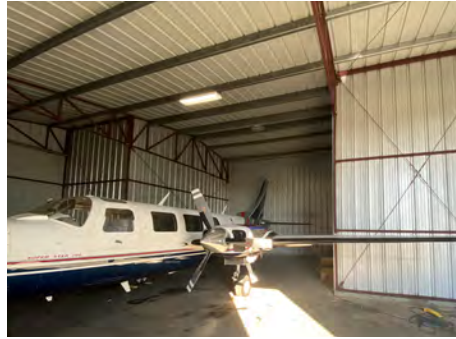
Hangar

<p><b>Structure</b> <span style="background-color: #fff9c4; padding: 2px 10px;">3.8</span></p> <p>Steel framing and other interior structural elements appear to be structurally sound with much remaining service life. Some structural wood contains elements of rot, especially in shop area.</p>	<p><b>ADA Compliance</b> <span style="background-color: #f08080; padding: 2px 10px;">Needs Compliance</span></p> <p>Interior clear floor space is not present at many portions of the interior. Thresholds are present at sliding floor bottoms at entrances to individual hangars.</p>

**Structure:** It is recommended to remove rot and replace structural elements in shop area.

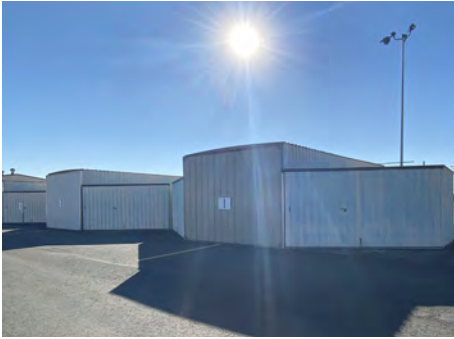
Exterior

2.7</p> <p>Steel exterior of F-Series hangars is rusted in places especially at entrance thresholds and door components. Paint has chipped which has allowed rusting. Paint is faded and hangars are not uniform in color. Flat roofs are discolored and rusting at edges. Tow hitches used for transport of hangars appear rusted and should be further investigated prior to transport. Door latching system is worn and had to utilize at many doors.</p>	<p><b>MEP Systems</b>

**Exterior Envelope:** Recommended actions include cleaning rusted areas of the hangar include entrance thresholds and door components, repainting the facade and making sure all hangars are painted in the same color, cleaning and painting flat roofs, potentially replacing tow hitches and replacing rusted door latching system.

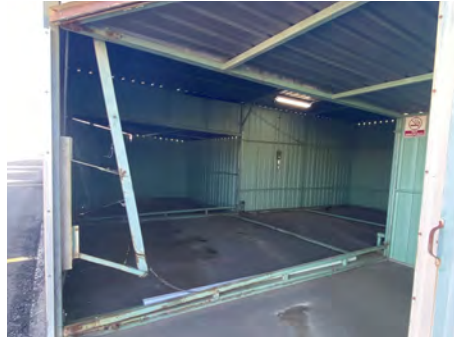
3.0</p> <p>Some staining is present at interior asphalt floors. Minimal cracking is present in flooring. Interior lighting lenses are discolored.</p>
<p><b>Exterior Envelope</b>

**Interior:** Recommendations include cleaning interior asphalt floors and interior lighting lenses.

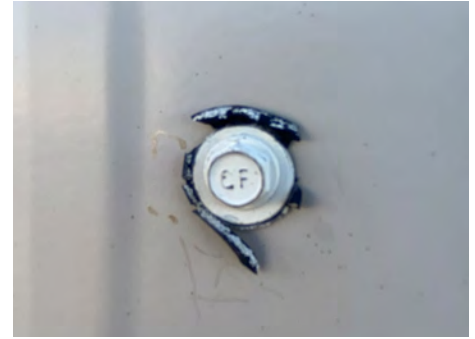
Rubber Washer

2.8</p> <p>Structure is rusting away at various locations, especially at door components. Replacement parts are unavailable and must be fabricated.</p>

**Structure:** It is recommended to order fabricated parts for rusted components throughout the hangar.

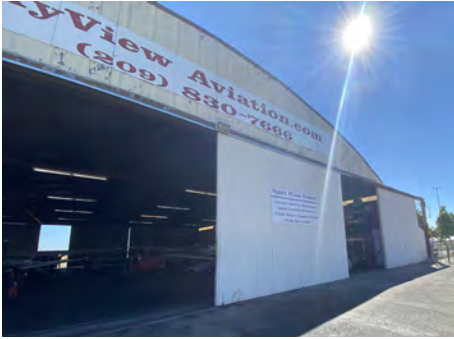
Exterior

The exterior metal siding is in fair condition with some areas rusted through with paint required. The roof has had reports of leaks over the last decade. Skylight panels are discolored and worn. The large sliding doors allowing aircrafts access to the hangar are on overly sized tracks that require excessive force to open and utilize.

**Exterior Envelope:** Recommendations include repainting exterior metal siding, replacing roof, replacing skylight panels, and properly sizing tracks for large sliding doors.
