## NOTICE OF SPECIAL MEETING

**Staff recommends that City Council conduct a workshop to review the Citywide Public Safety and Public Facilities Master Plan Updates and provide feedback.**

The Citywide Public Facilities Master Plan (CPFMP) Update provides a comprehensive update to the 2013 CPFMP by evaluating the condition of existing public facilities and determining current and future public facility needs. The CPFMP Update includes facility condition assessments of all City facilities with recommended improvements for proposed new public facilities projects. Recommendations for renovations at City Hall, improvements and new facilities at the Boyd Service Center, and an expansion of the Community Center and Lolly Hansen Senior Center are provided as well.

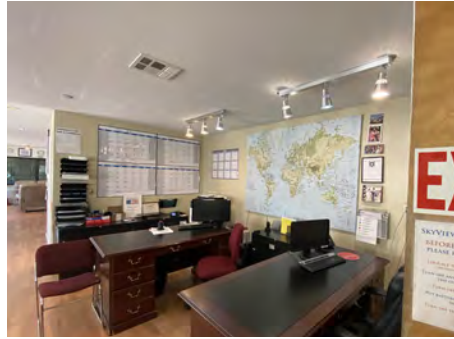
Some evidence of wood rot is present at hangar structure. Interior lighting is just adequate and could be modernized. Current tubes are fluorescent with some units out of discolored. Asphalt flooring is pitted in areas but generally works well for the operations of the facility. Flooring in administration and office areas differs throughout but is largely rolled carpeting in fair condition. Green carpet is original to the building. Previous mold issues present at interior asphalt has led to mildew prevention efforts. Windows are in good condition as double-paned glass has recently been installed. Ceilings are plaster in office areas and painted white. Hangar area has exposed wood and metal roof structure as ceiling.

**Interior:** It is recommended to repair hangar structure, modernize interior lighting, and improving the flooring within the administration and office areas.

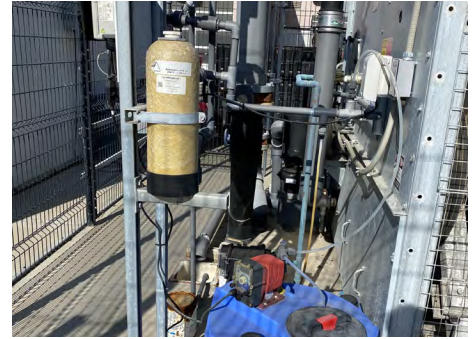
MEP

Electrical switchgear is in good condition with remaining useful service life. Issues with the closed loop water system include water-sourced heat pumps that are failing at a quick rate. In total, the facility has 38 units and 8 have already been replaced with all requiring replacement. A 1000-gallon emergency diesel generator allows power to the building for 7 to 10 days in the event of normal power loss. This generator may require servicing but has no reported issues. A new fire alarm system including fire panel, smoke detector heads and fire alarm lighting were

**MEP Systems:** Investigate cause of ceiling tile stains, possibly from closed loop water system drainage pans located above ceiling. Provide new ceiling mounted heat pumps for same system. Maintain new fire alarm system as directed by manufacturer.

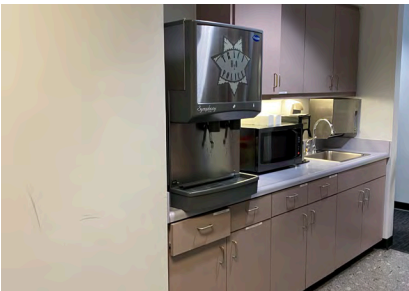
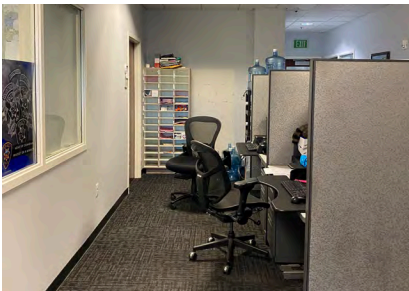
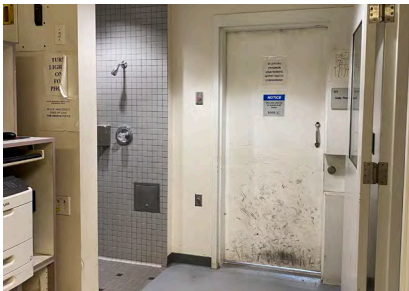
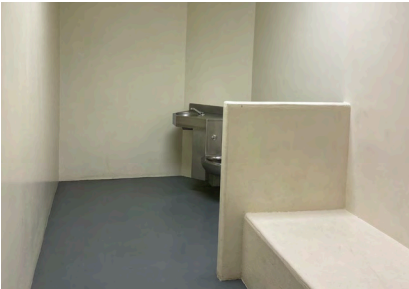
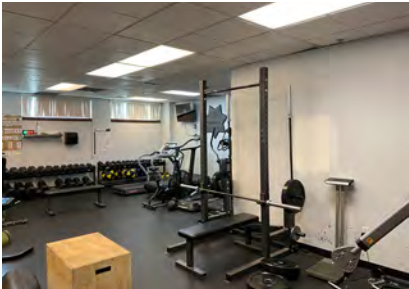
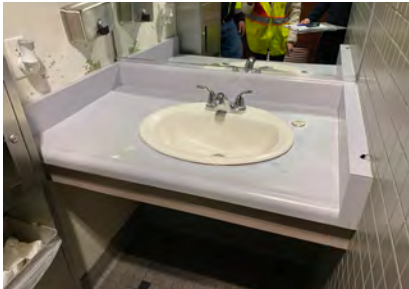
Photo Documentation | Interior Blow Ups

D. Urinals		4					
	E. Lavatorie /Sinks			3				
	F. Counter			3				
	G. Shower Compartments				2			
4.7	Hazmat							N/A
4.8	Room Capacity							N/A
N O T E S	4.1.A: A selection of suspended ceiling tiles contain signs of ceiling leakage.

4.2.B: Vinyl flooring throughout the facility is scuffed, scratched and misaligned in areas.							
	4.2.E: Concrete floors are cracked and deteriorating especially in jail area.

**Interior:** Provide door seals at bottoms of exterior doors that lack them, including in jail area. Paint interior walls throughout building. Replace stained ceiling tiles and investigate cause of staining.
